## INCORRECT QNH SELECTION

Di seguito un Safety bulletin di IFALPA, che riporta gli eventi più significativi, i sistemi di protezione esistenti e riassume le principali raccomandazioni per gli equipaggi di volo.

Here below is an IFALPA Safety Bulletin, which reports the most significant events, the existing protection systems and summarizes the main recommendations for flight crews.

# Incorrect QNH Selection

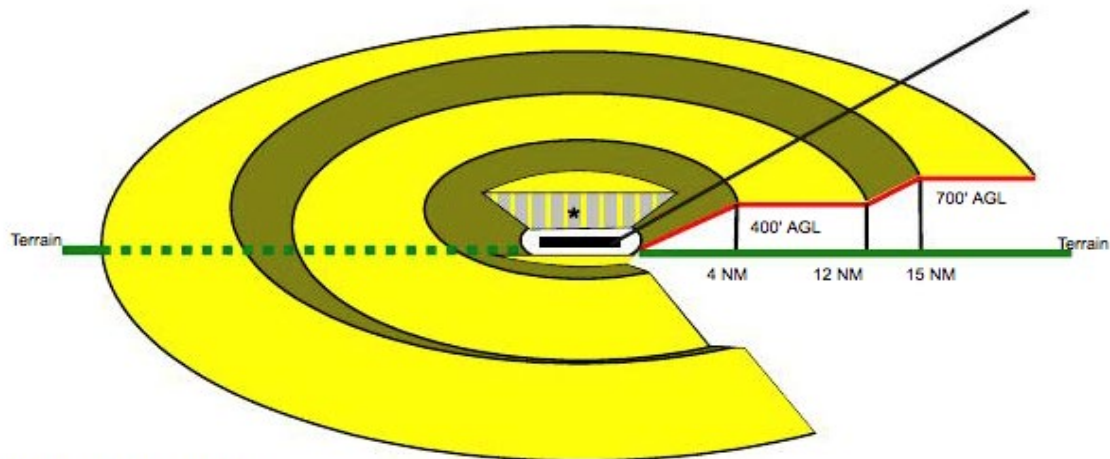
Both aircraft were equipped with eGPWS, which incorporates the Terrain Clearance Floor (TCF) and Runway Field Clearance Floor (RFCF) enhancements:

- TCF creates an increasing terrain clearance envelope around a runway and its alerts are based on current aircraft location, nearest runway position and radio

altitude. TCF complements existing Mode 4 by providing an alert based on insufficient terrain clearance even when in landing configuration.

- Runway Field Clearance Floor (RFCF) is similar to the TCF feature, except that RFCF is based on height above the runway elevation instead of radio altitude.

In both cases no aircraft hardware alert was provided to the flight crews, as the respective flight paths were outside the eGPWS activation envelope, either slightly too close to the runway or too high for the system.

\*245 foot curve expansion on runway sides only applicable to -210-210 and on.
